Keswick Dam –Red Bluff Reach

**Sacramento River Conservation Area
and
Inner River Zone Guidelines**

Reach 1 (Keswick Dam to Red Bluff Diversion)

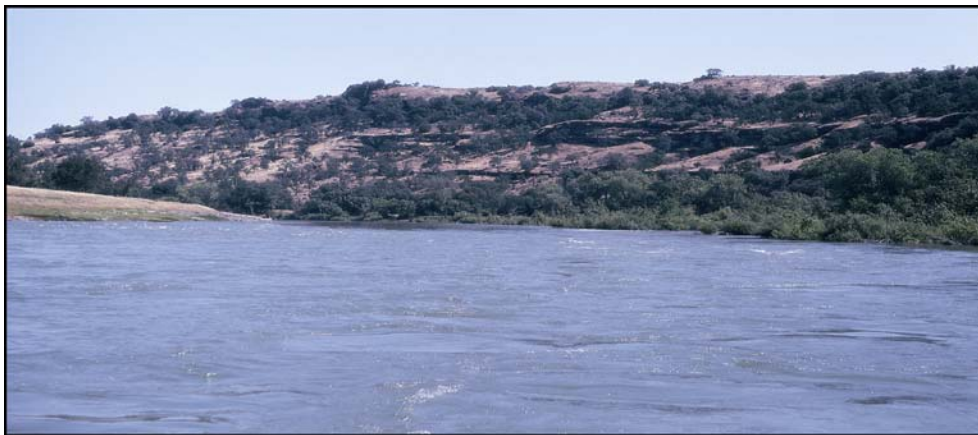
Figure 3-3. *Narrow corridor of riparian vegetation bordered by native upland vegetation*

Table 3-3 presents a summary of the riparian and closely related habitats within the Conservation Area. Because portions of the channel within this reach are geologically confined, the width of riparian vegetation is often very narrow (Figures 3-3 and 3-4). Areas with potential for the development of large tracts of riparian vegetation are often converted to agriculture or are under other types of development. Approximately 128 acres of valley oak woodland are contiguous with the outer boundaries of the 100 year flood line.

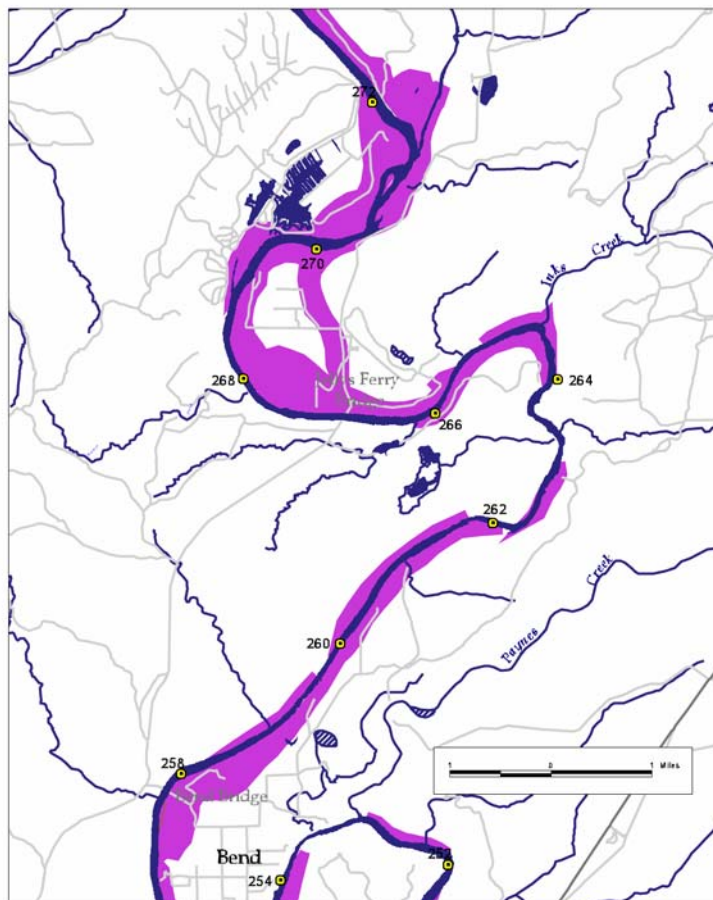
Figure 3-4. Sacramento River near Bend (RM 257-273) showing area inundated by a 2.5 year recurrence interval flood
